EXPOSURE

vol. 8 no. 3

a newsletter for ocean technologists

July 1980

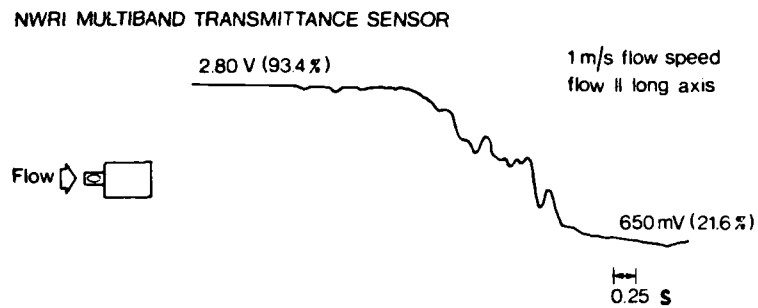
FIGURE 2.

This procedure was done for two sensor orientations: one with the flow perpendicular to the ports and the long axis of the sensor, and the other with the flow parallel to the ports and to the long axis of the sensor. As expected, the first orientation had better flow characteristics for clearing the active volume. The time required to 63 percent of final reading was 0.34 seconds and to 98 percent was about 1.7 seconds. This was repeated at a tow speed of 0.5 m/s with nearly identical results. The second orientation times are 1.4 seconds and 5 seconds, respectively, for the 63 percent and 90 percent values. See Figure 2.

Care should be taken when extrapolating these time constants to other speeds because the hydrodynamic flow past the sensing volume may very well be nonlinear. Also, the curves presented do not exactly follow a classical single pole response. One can make the conclusion, however, that these time factors can result in delay and distortion in the profile, particularly in areas of high transmittance variation with depth.

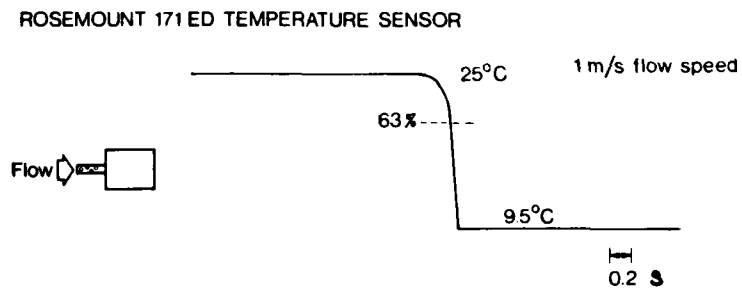
FIGURE 3.

underwater case. A plastic bottle filled with an ice water slurry was mounted over the sensor probe. This bottle was rapidly pulled off, as before. The time required to attain 63 percent of the final reading was 65 ms at 1 m/s. See Figure 3. This compares favorably with the manufacturer's 60 ms value at 3 ft/s. The time constant is not greatly affected by flow speed. The values at 50 mm/s and 20 mm/s are 70 ms and 90 ms respectively. This particular sensor appears to follow a single pole response reasonably well. The small fluctuations observed are due to temperature gradients in the tow tank.
